A Renewed *Abi* for Urkesh:

Archaeological Conservation at a Distance

S. Ermidoro – Y. Mahmoud*

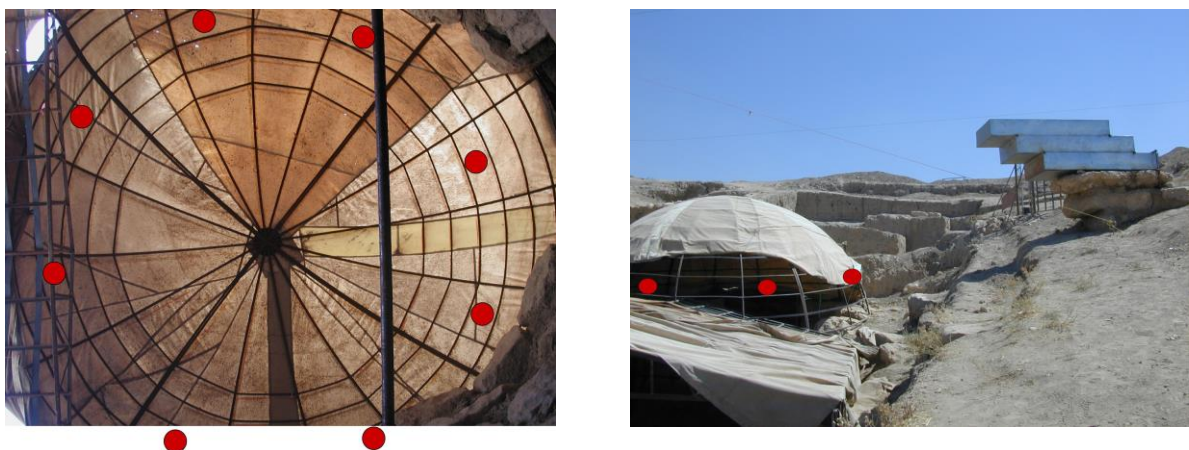
Fig. 1: Photos with the indication of the openings to be created in the new metal dome for aeration and light inside the *abi*

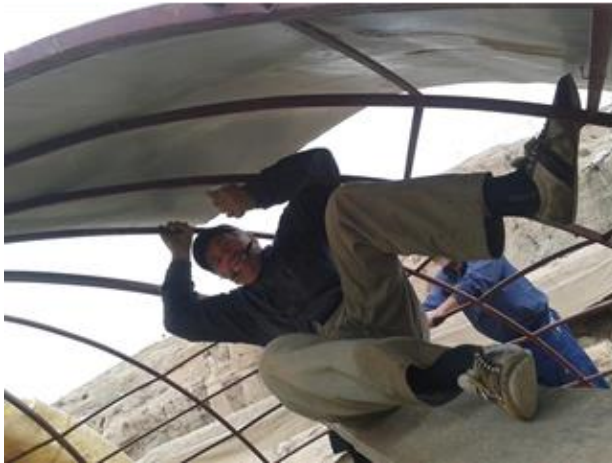
Fig. 2: First day of work on the *abi* dome

Unfortunately some problems in communication, in particular over the telephone lines, which were often broken thus impeding fast communication to Syria, delayed again the beginning of the job, which then started only December 3rd (the first photograph taken this day can be found here below, Fig. 2).

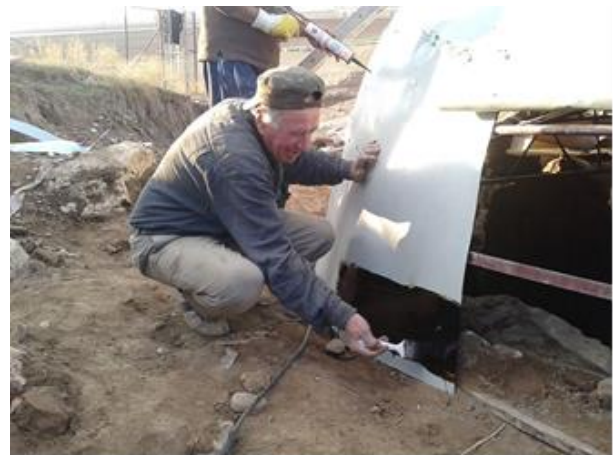
Fig. 3: applying pitch at the base of the Dome

avoid painting it the exterior surface: he decided instead to paint only the base with pitch - on those parts of the structure that would have been covered again with soil, as shown in the photo on the right (Fig. 3).

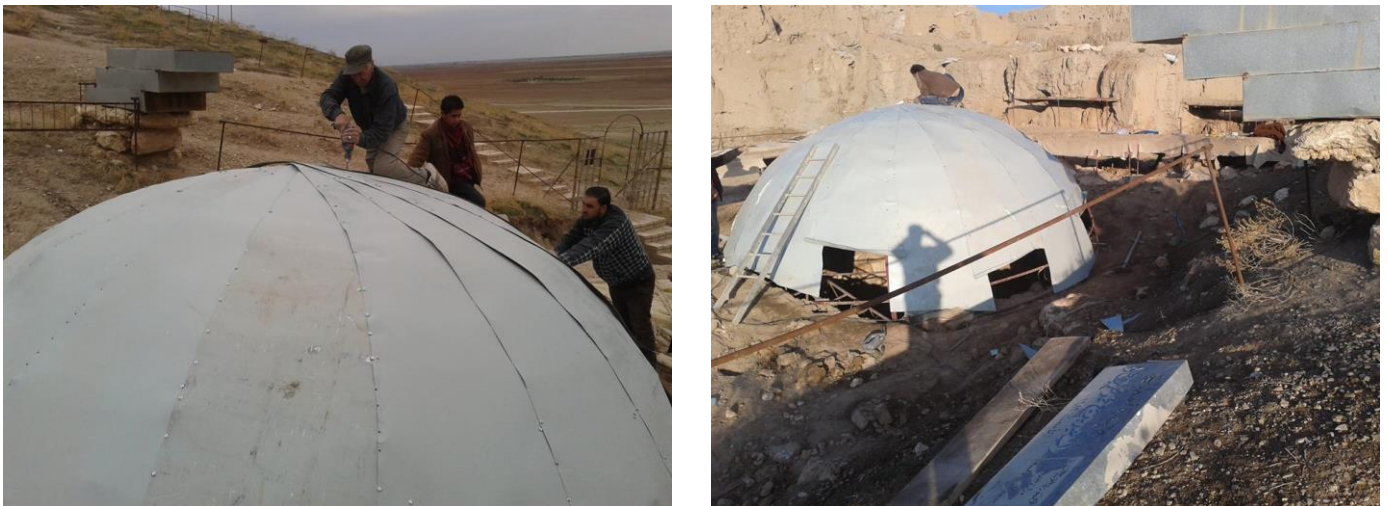
Fig. 4: Sabah Khasseem at work (left) and detail of the openings at the base of the new *abi* dome

Having discussed with Mohammed Omo the project, the smith initially decided to use only metal for the dome, adding openings for the ventilation inside the *abi* but not including the transparent panels that were originally envisaged in the project. However, thanks to the constant communication that we had started with him via the internet and the telephone, it was possible to stress the importance of having some light inside the *abi*, and he changed the structure accordingly (Fig. 4).

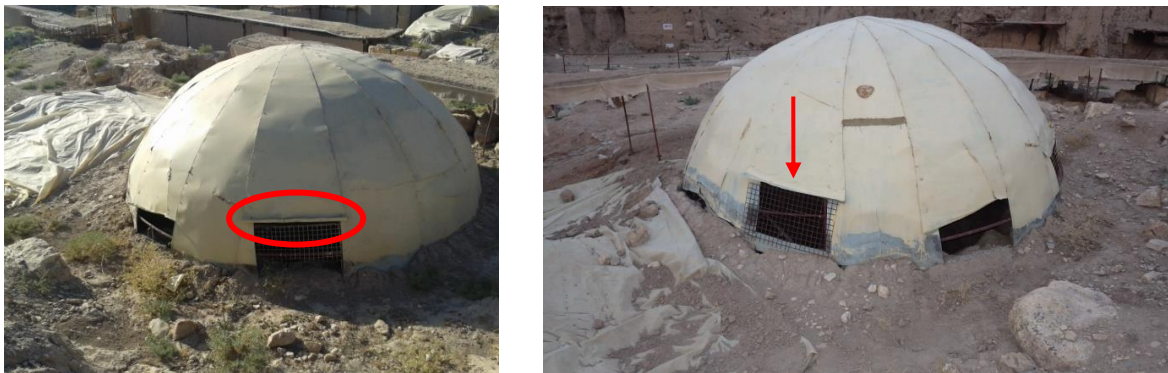
The ventilation openings for which we had asked in the new structure were working well, preventing overheating and allowing some light inside the *abi*. Three small openings have been left at the bottom of the dome, at its southern and south-western sides: these are

rectangular in shape, and covered by a metal net to prevent animals and any other external elements from entering the structure.

Fig. 5: Showing the openings and the drains above the openings

Each one of these openings has a thin metal sheet on its top, which is tilted upwards and slightly longer than the holes themselves: this has been done for a specific reason. As can be seen in the photo, these unobtrusive installations create a kind of small drains, so that rain is channelled and seeps out, preventing the water from leaking into the *abi* (Fig. 5).

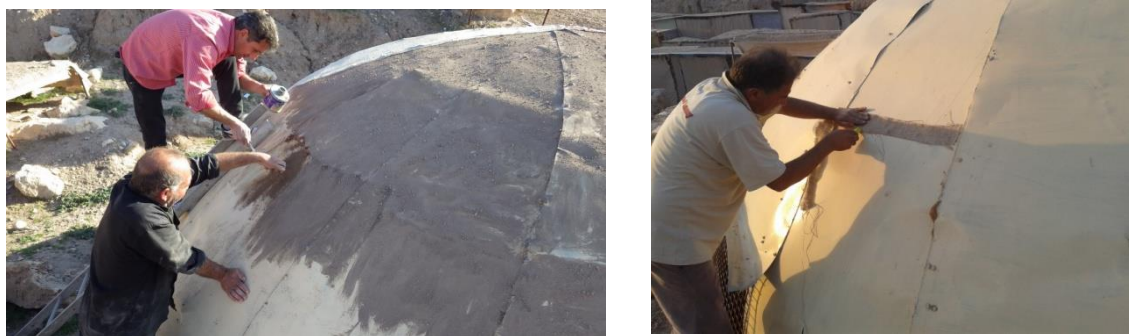
Fig. 6: Covering half the dome with dirt (6a, on the left) and the experiment with burlap (6b, on the right)

After having discussed it with Prof. Buccellati, Federico Buccellati, Samer Abdel-Ghafour, and Stefania Ermidoro, in June 2014 the team resolved to try two different methods that the workmen put in place right away. The first one was covering the dome with adhesive and then applying a light layer of fine dirt directly above it; the second was to cover the structure with adhesive and then place burlap on it.

The dome was therefore completely covered, but using the two methods – each for one half of the structure: half was covered with dirt (Fig. 6b), the other half with burlap (fig. 6a). Initially, both methods seemed to give the dome a very natural look and to be unobtrusive with regard to the surroundings (Fig. 7). However, we had to observe how the two systems reacted in a longer period: thus, we asked our workmen at the site to look carefully at the dome in the following months in order to check how the covering system reacted to the atmospheric agents and in general to the passing of time.

After a period of observation, we determined to use the burlap for the entire dome – substituting the half covered with dust whenever the meteorological conditions would have allowed it.

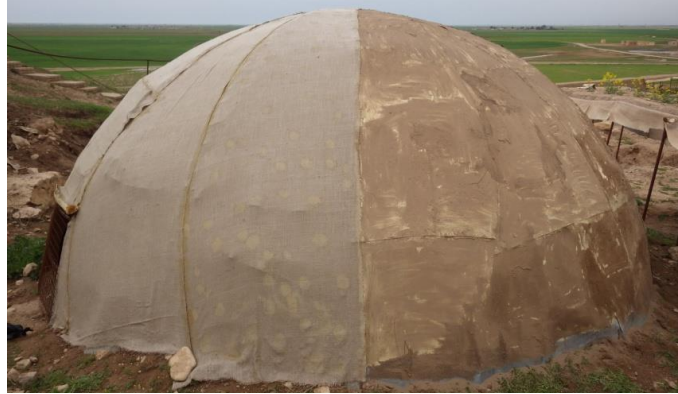
Fig. 7: The *abi* in June 2014

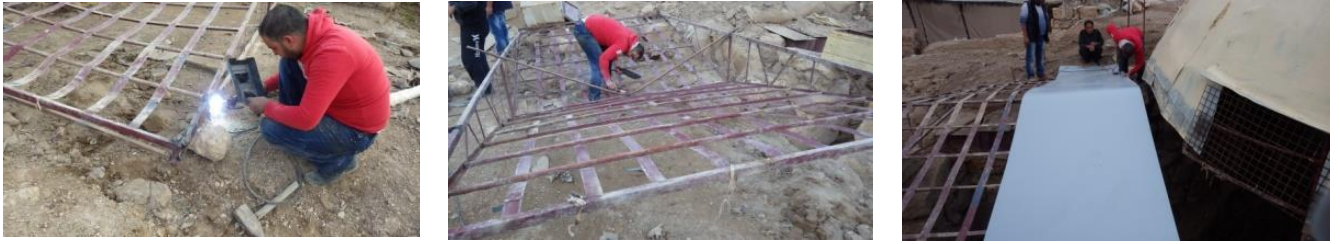
During the fall 2013 and winter 2014, this particular system suffered a great deal and was badly damaged due to weather conditions (especially snow), plus it was dented in several places and needed maintenance to ensure an overall full protection. The workers had taken some emergency measures to stop the water from seeping in, by placing pieces of nylon in the brakeage locations. However, a serious structural intervention was needed.

Fig 8: Different stages of work on the entrance

The smiths in Mozan began the project on the December 4th, 2014. They began by removing the plastic cover, the dirt and the fabric. After that, they exposed the metal frame: since its original set up, this was placed atop some dirt bags located on the edge of the entrance top – in doing so, we made sure that the metal did not touch any part of the original stone structure.

At first, the workers removed the whole metal structure, in order to evaluate its condition and fix its damaged junctures. The parts which were dented were straightened using a hammer, and a supporting bar was placed at the central top point of the top and extended to the two bases, welded to provide extra stability and support (Fig. 8).

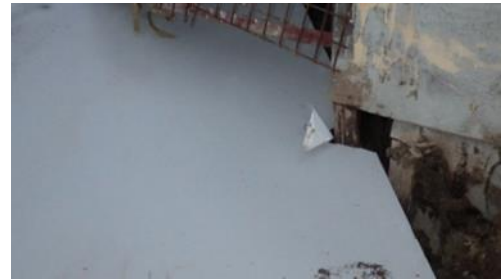
Fig. 9: Junction between metal sheets of the entrance covering and those of the *abi* dome

This metal frame was then placed back over the entrance of the *abi*, partly beneath the dome, and completely covered with metal sheets that were screwed into the metal frame. A small opening was made in the metal sheet, in order to interlace it with the metal frame of the dome and to ensure that it was as close as possible to it, in an attempt to leave the minimum possible space between the dome and the entrance frame (Fig. 9). Whatever opening was left, it was later covered with metal sheets and dirt as well to ensure waterproofing.

Similarly to what had been done on the dome, the metal sheets used for the entrance cover were placed in an overlapping method, and screwed into the metal frame. Since they were longer than the underling structure, the extra pieces on both edges were not removed, but instead they were bent to form a drain, lower than the metal frame, so that rain water would be channelled away from the stone forming the architectural structure.

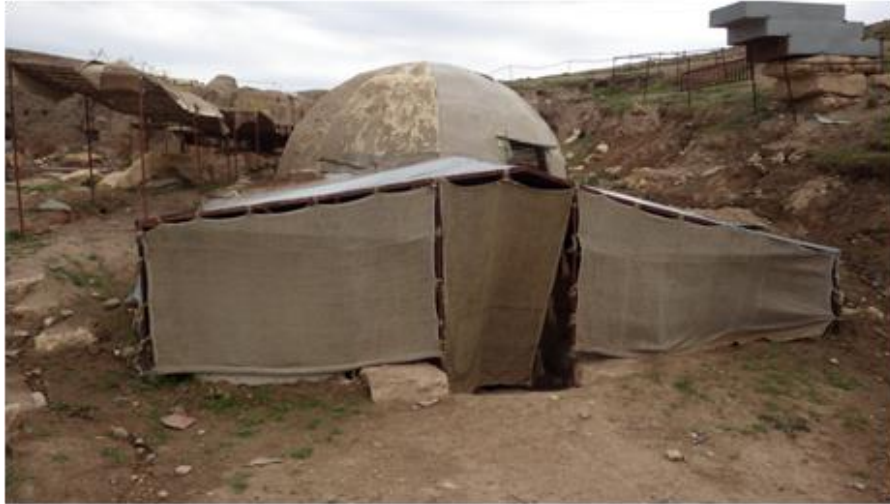
Fig. 10: The *abi* in December 2014

Finally, the curtains used on the sides of the entrance and on its façade and doorway were replaced with new ones (Fig. 10).

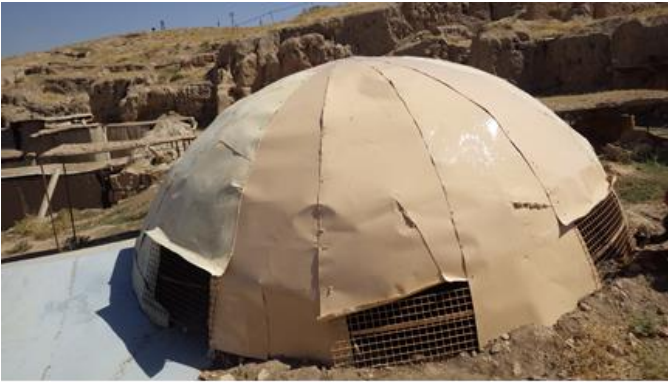
We realized that neither of the two previously experimented system with the *abi* dome was efficient: the two halves, covered with glue and dirt or with glue and fabric, did not resist sufficiently the local weather conditions. The burlap was ripped by wind and deteriorated because of the rain and snow, and for the same reason also the dirt layer was not uniform, but patchy. The overall impression was that of a neglected situation which we obviously wanted to avoid. Therefore, we decided firstly to clean the entire dome surface from any leftover dirt or glue, and then to paint it with a color close in shade to the surrounding. This paint coat will also prevent rust form forming.

Fig. 11: Painting the dome in 2017

Our workmen from Mozan, thus, went to a local paint shop and discussed the best shade of color for our purpose: after having found the best blend of two different types of paint, they used it to cover the entire surface of the *abi* dome.

At first, the paint looks shiny but after it dries out it becomes opaque and slightly darker. The result, as shown in the photos on the left taken while the painting was still in progress (Fig. 11), is the closest possible color to the surrounding environment: it is thus unobtrusive and coherent with the rest of the protection system of the entire Palace Area.

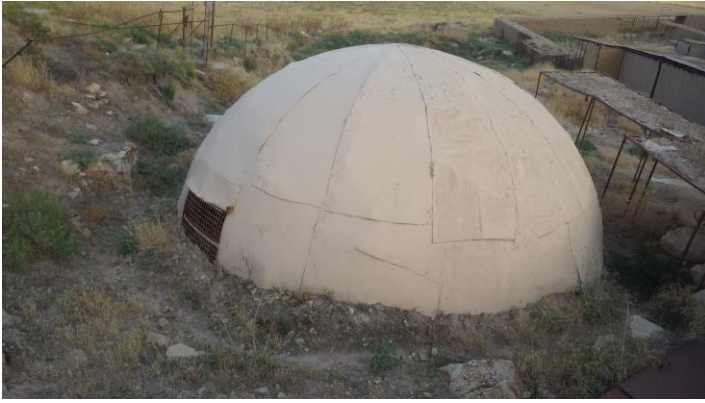
Fig. 12: The abi in June 2020

The minimum work that the new dome has required so far has been the refilling of the gaps between the metal sheets with silicon.
